Manhole Inspection Summary

Manhole # S35A__029MH

Insp Date: **11/14/08 10:13 AM**

Location Address: **508 st paul st**

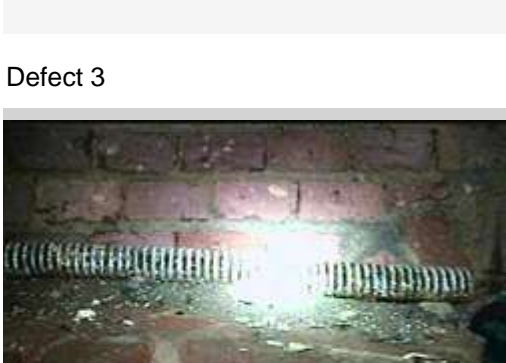
Condition: ☐ Sound ☐ Cracked ☐ Root Intrusion ☐ Deteriorated ☐ Leaks ☒ **Debris**

channel debris

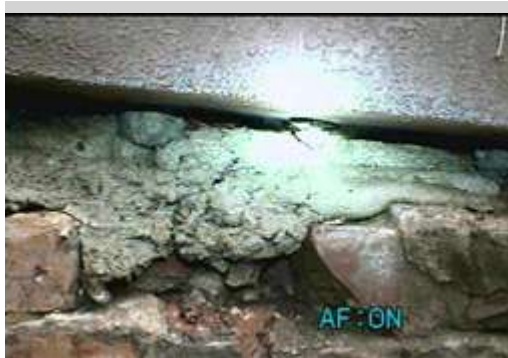
Defect 2

Condition: ☐ Sound ☒ **Cracked** ☐ Root Intrusion ☒ **Loose Brick** ☒ **Deteriorated**

chimney cracked loose bricks deteriorated

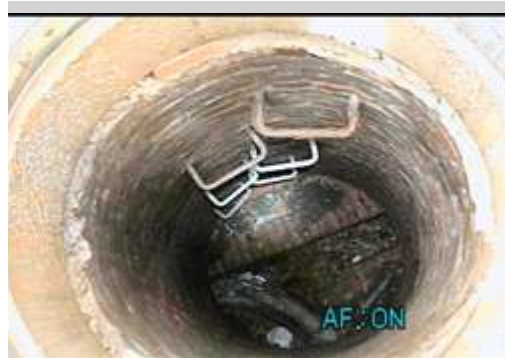
Defect 1

steps corroded
